**ELLIS ISLAND
STATUE OF LIBERTY NATIONAL MONUMENT**

**HISTORIC STRUCTURES REPORT
UNITS 2, 3 AND 4**

**Volume 4
Part Two**

**Beyer Blinder Belle/
Anderson Notter Finegold**

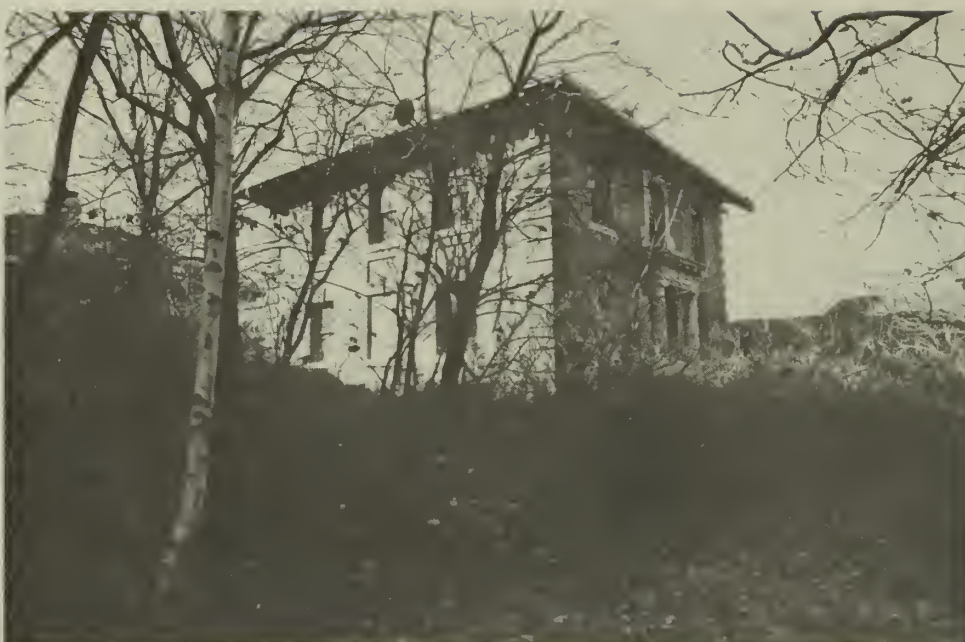
2. Office building, north and east elevations,  
view southwest.

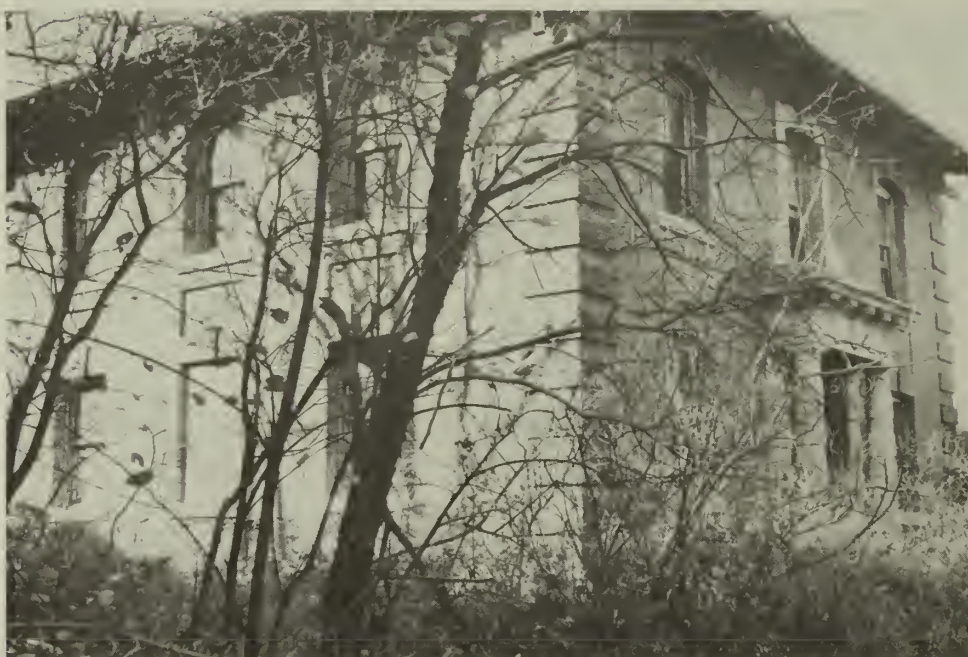
3. Office building, north and east elevations,  
view southwest.

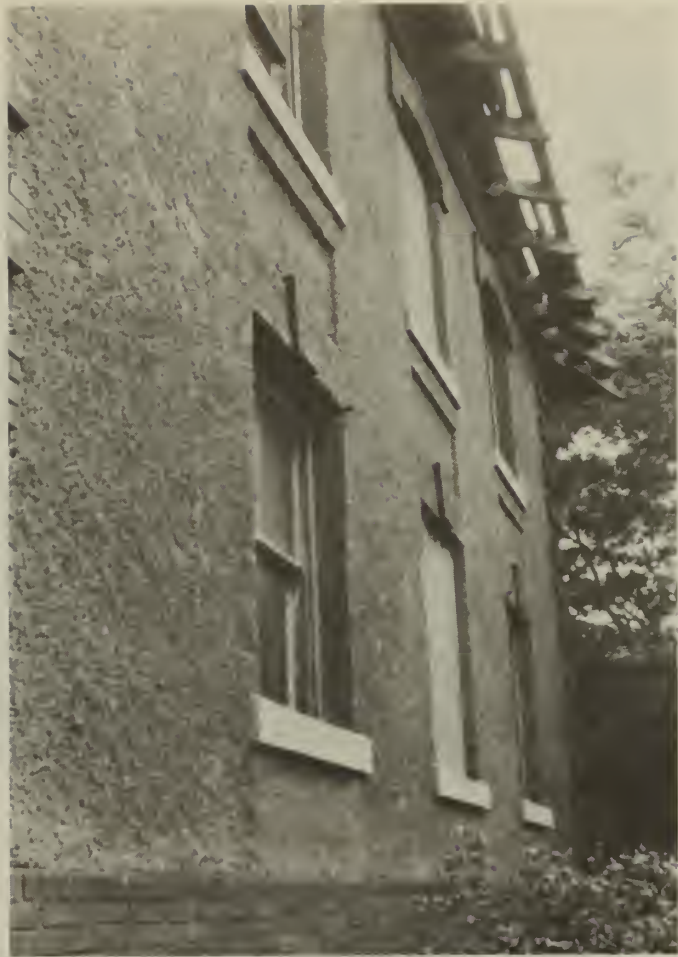
Stucco infill panels replace windows of the center bay on the first story of the east elevation and on both the first and second stories of the west elevation (photo 4).

4. West elevation with stucco window infill panels, view southeast.

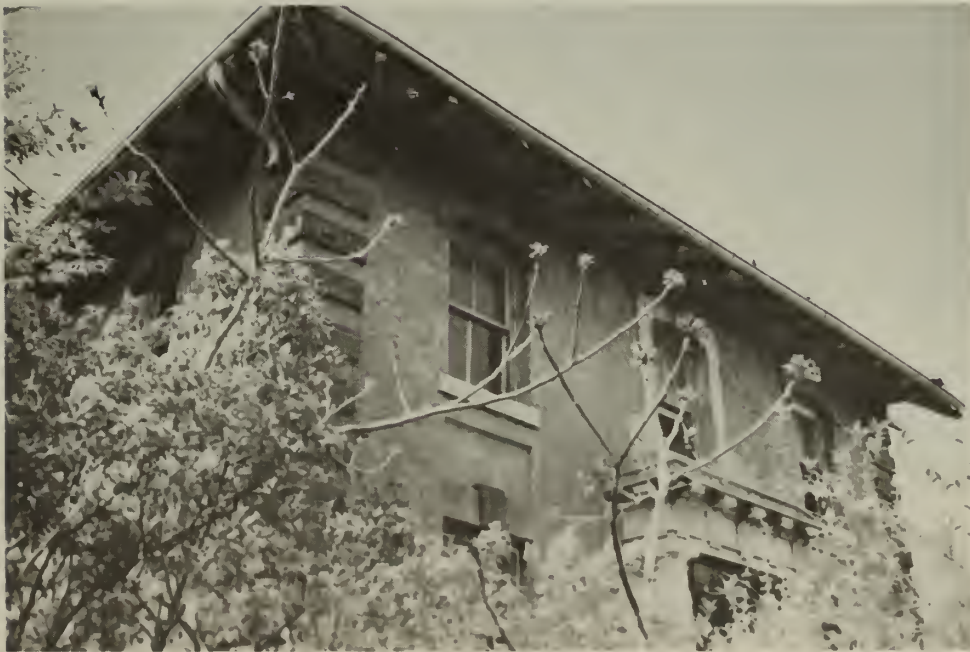
5. North elevation, view southwest.

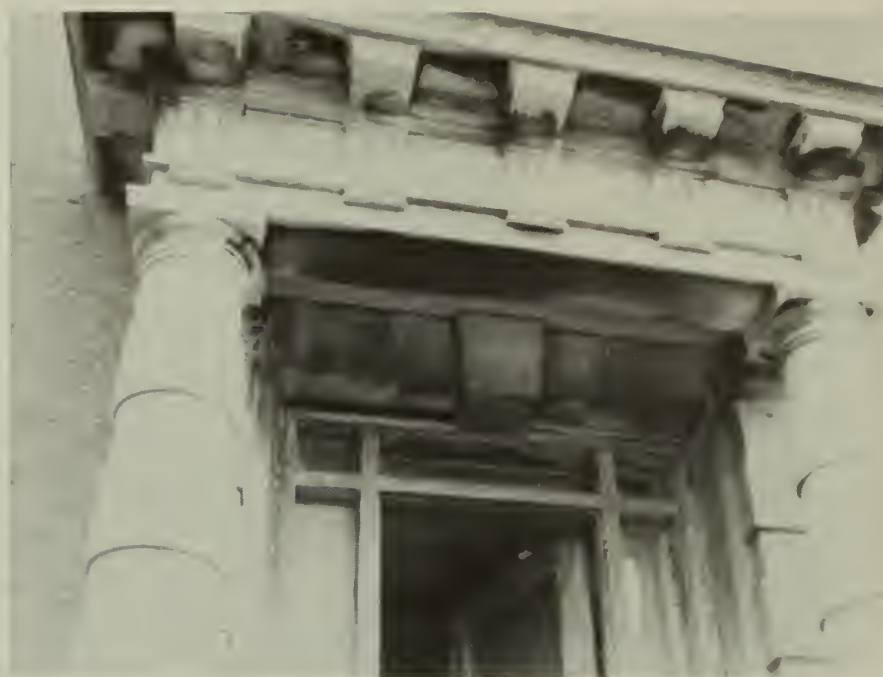
6. North portico.

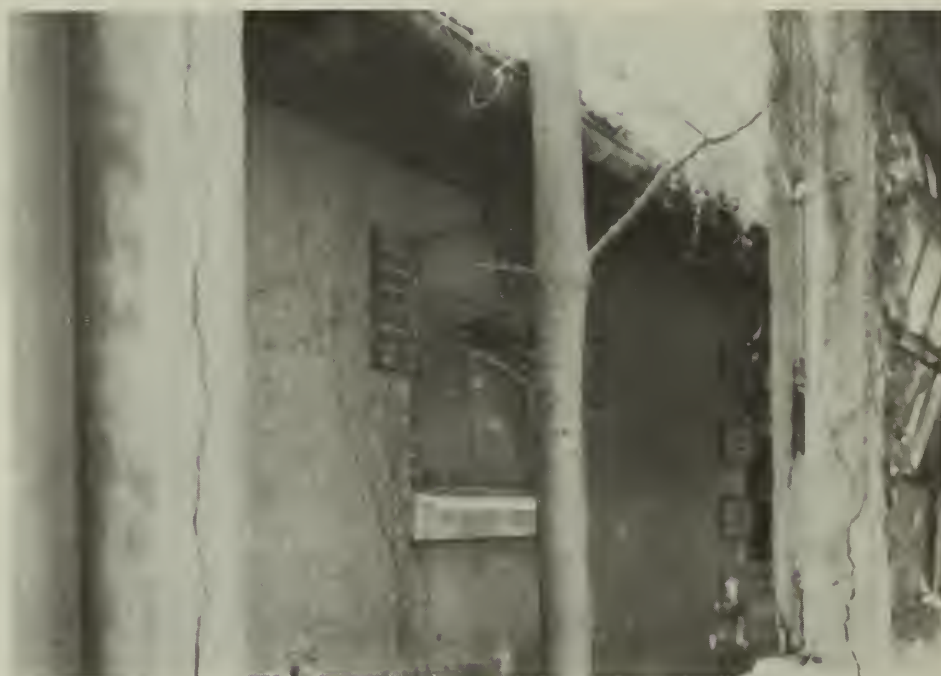
7. West elevation of mortuary, view from covered way 9A.

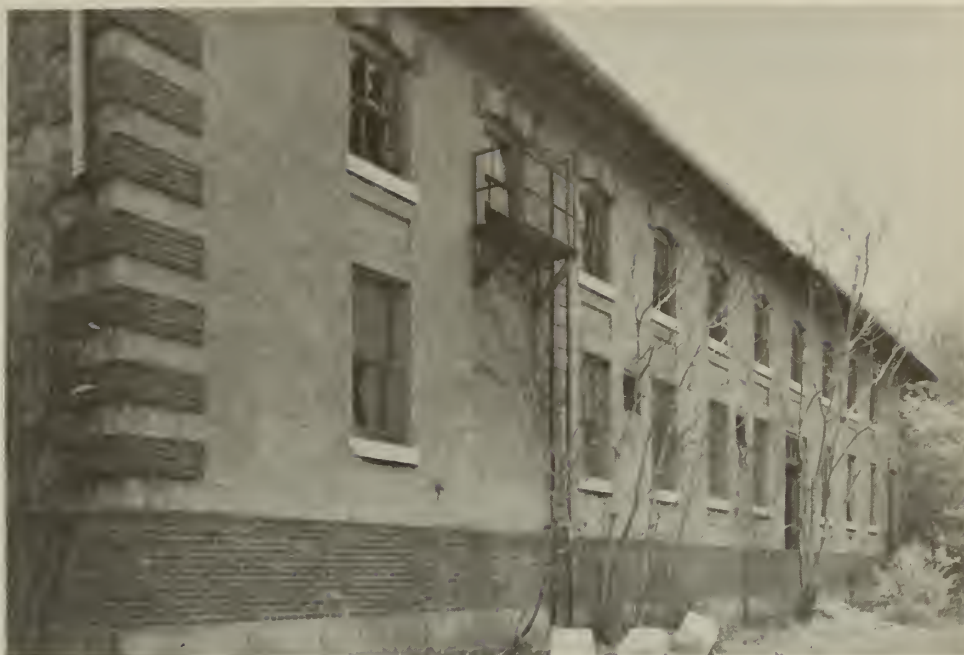
1. South elevation, view northeast.

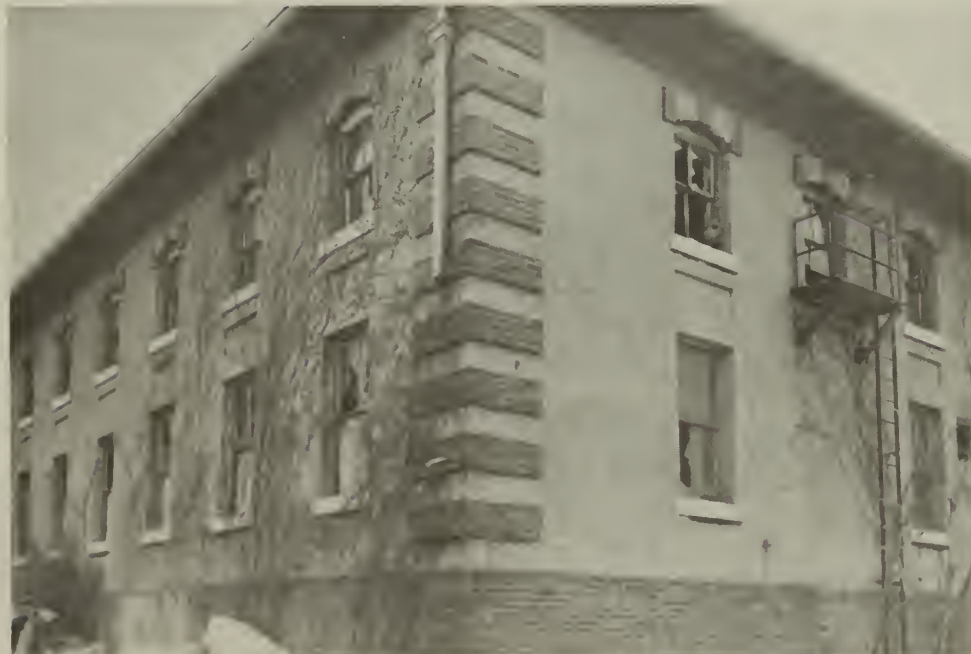
2. Southwest corner of powerhouse, view northeast.

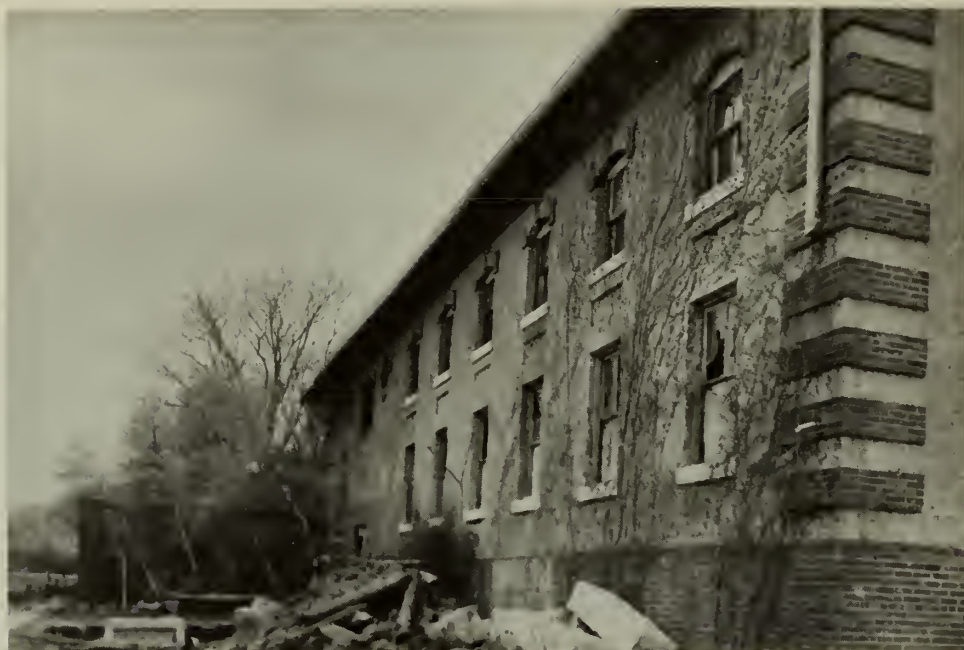
3. West elevation, view northeast.

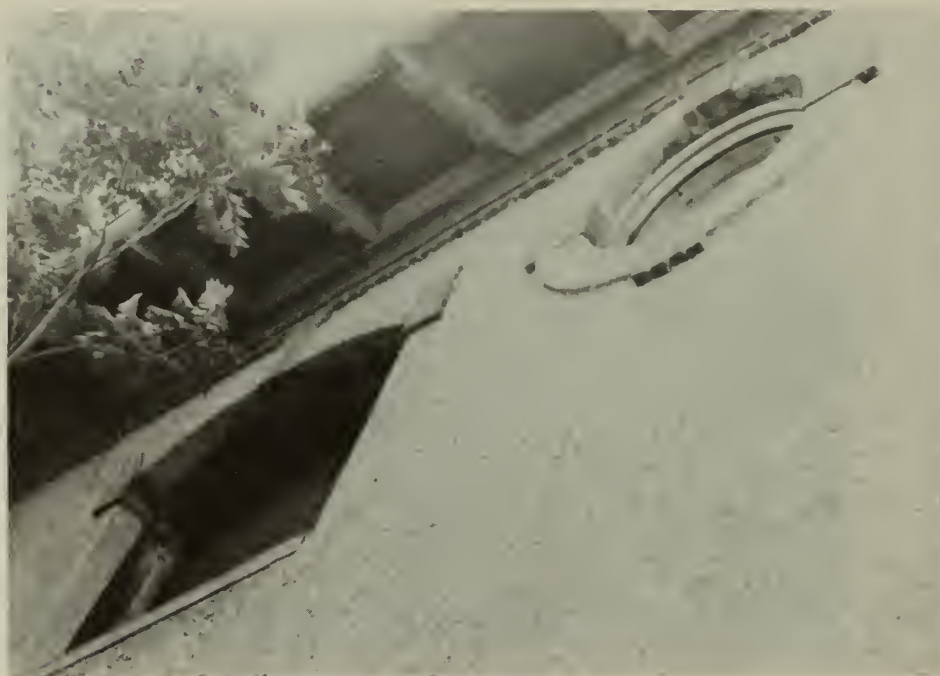
4. Round window and steel doors to boiler room, west elevation.

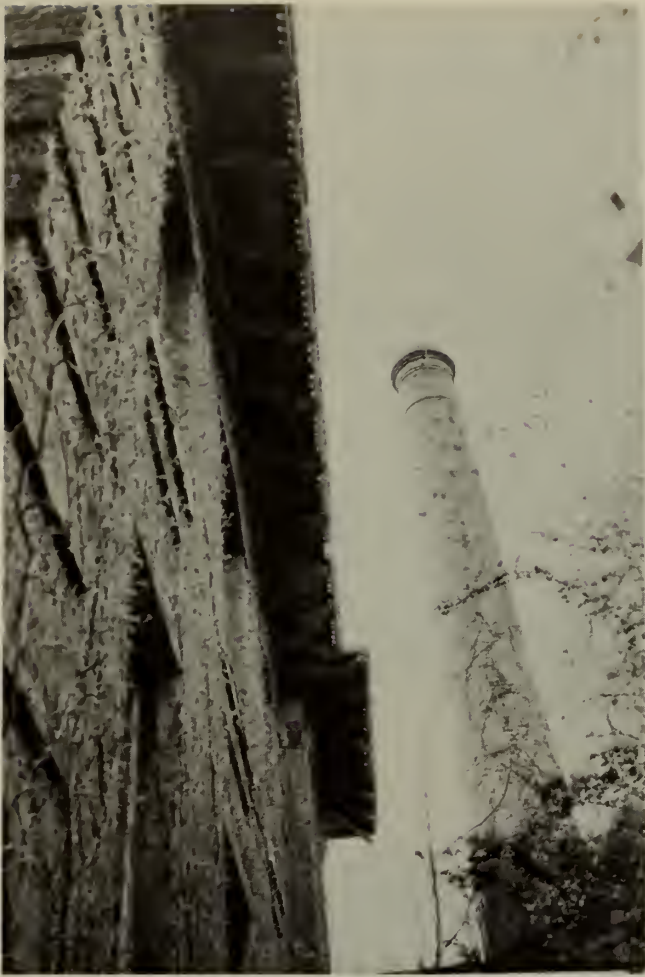
5. Powerhouse chimney, view south from west side of measles ward G.

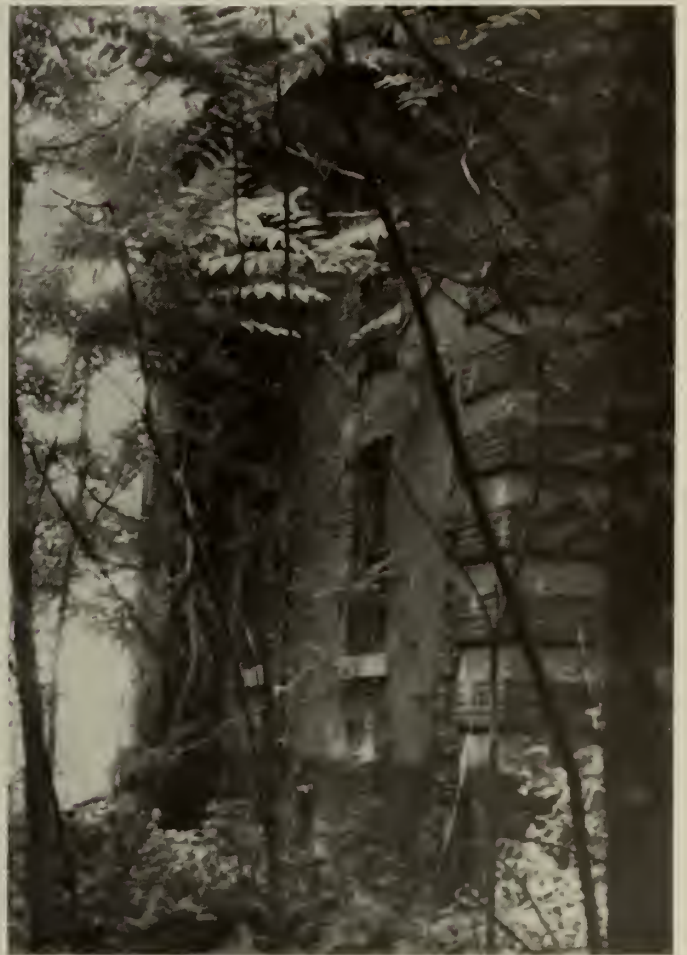
6. East elevation, view southwest.

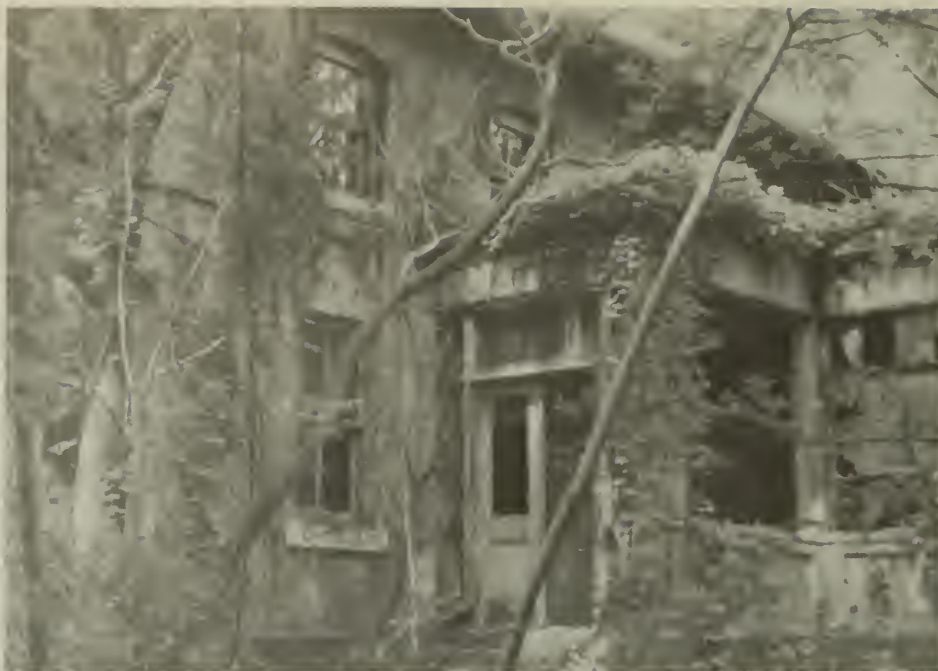
7. North elevation, view southwest; link with covered way 9A.

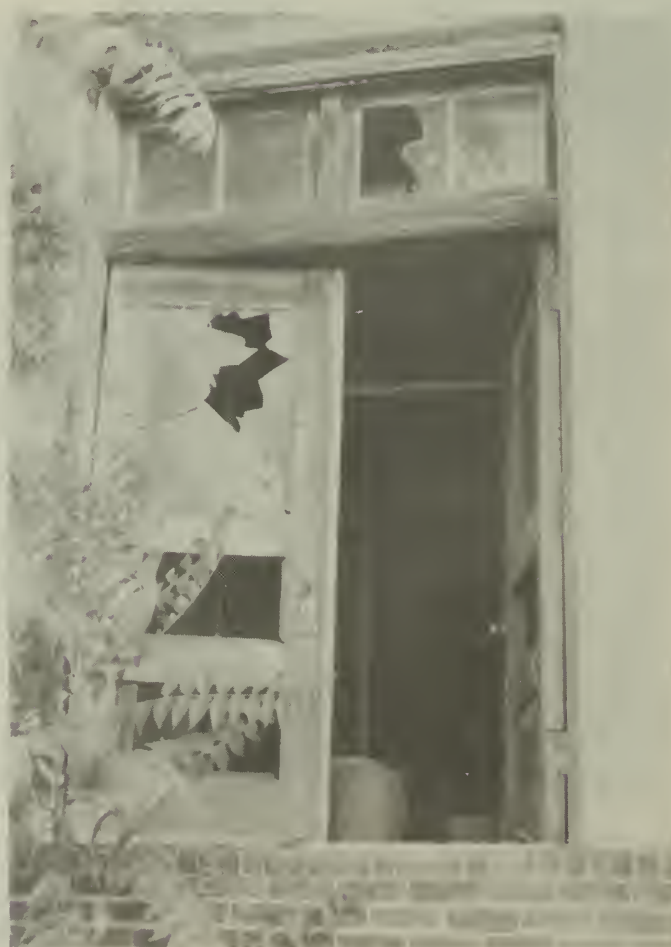
8. Loss of pebble dash aggregate in areas surrounding double doors, south elevation.

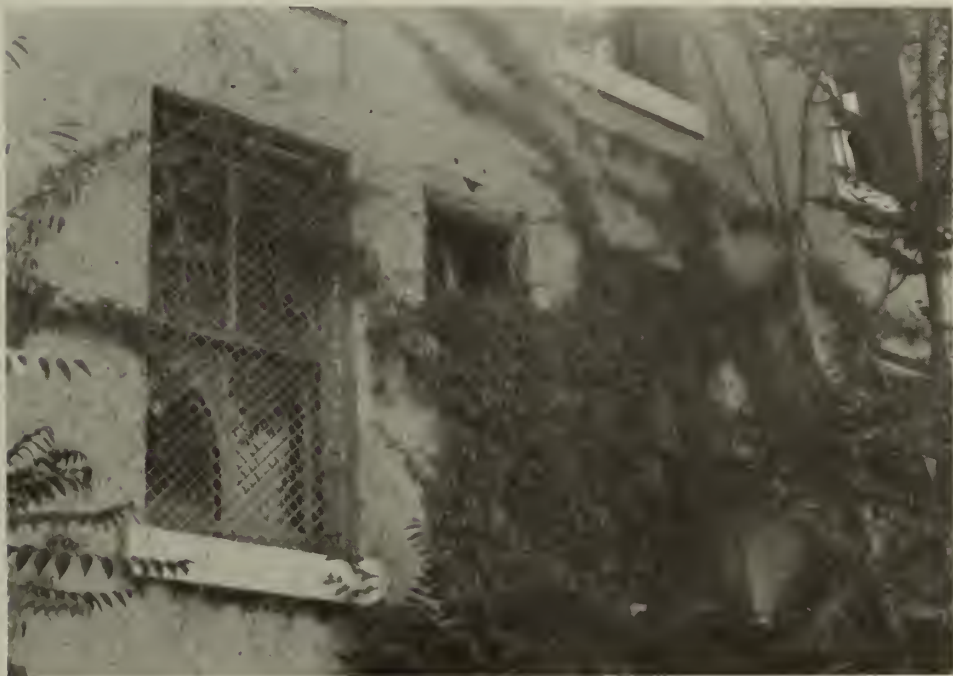
14. Vine cover, east end of south elevation.

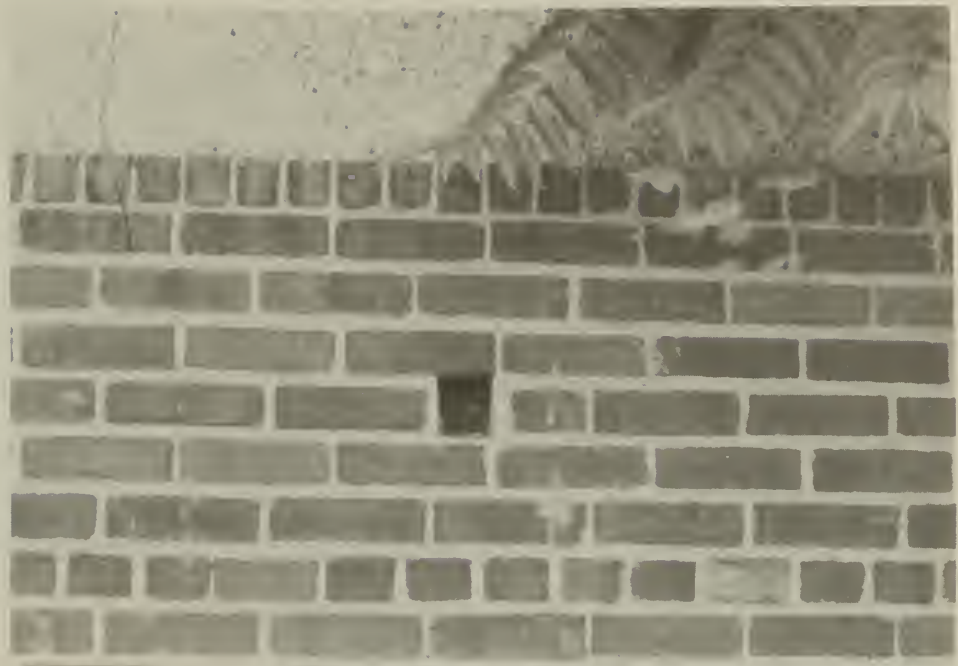
17. Removed brick, base of south elevation,  
third bay from west end.

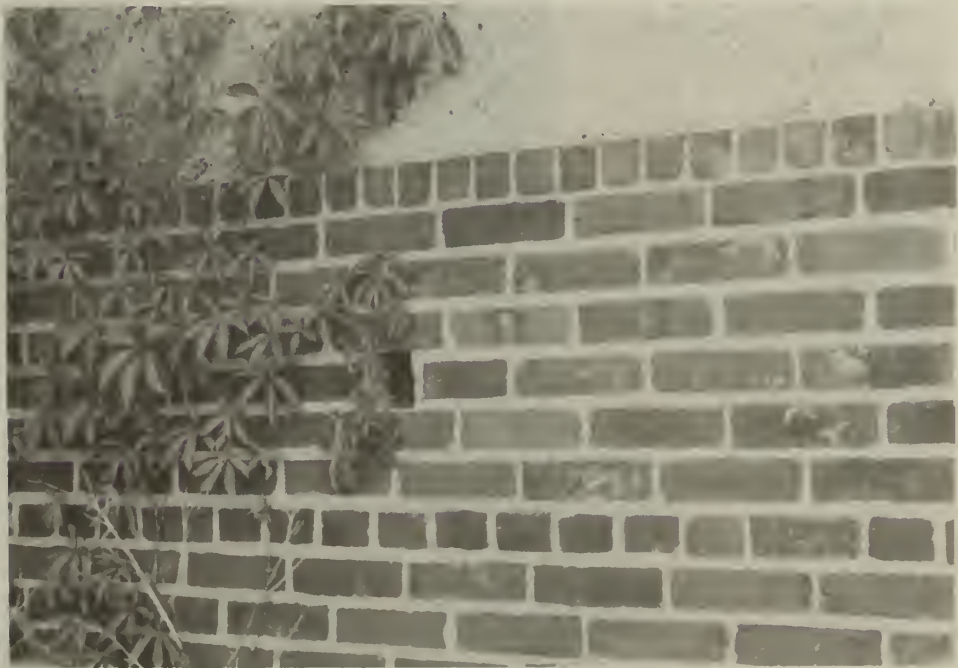
18. Removed brick, base of south elevation,  
fourth bay from west end.

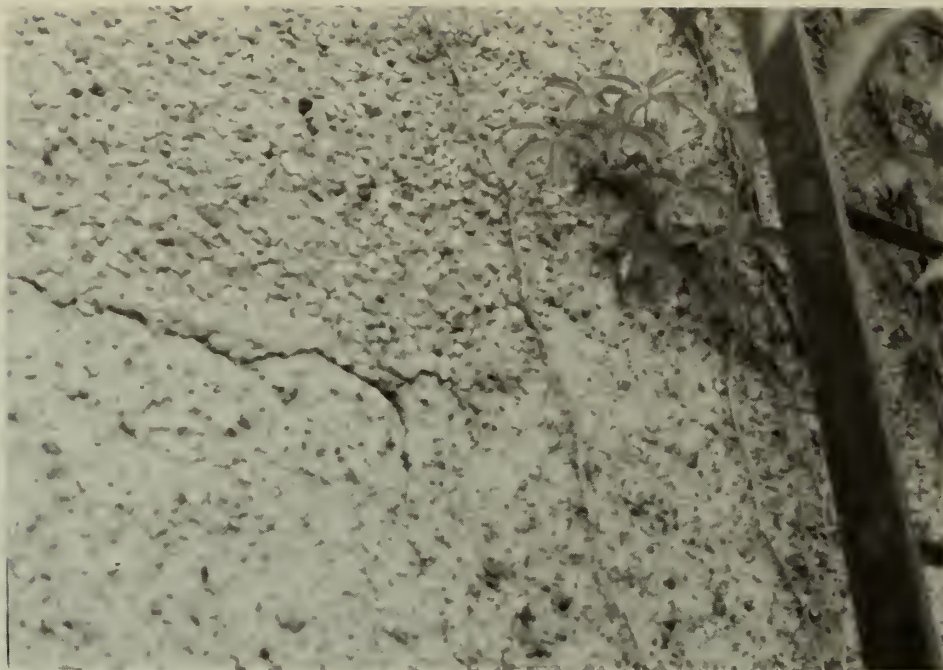
19. Variation in pebble dash aggregate, infilled window, south elevation.

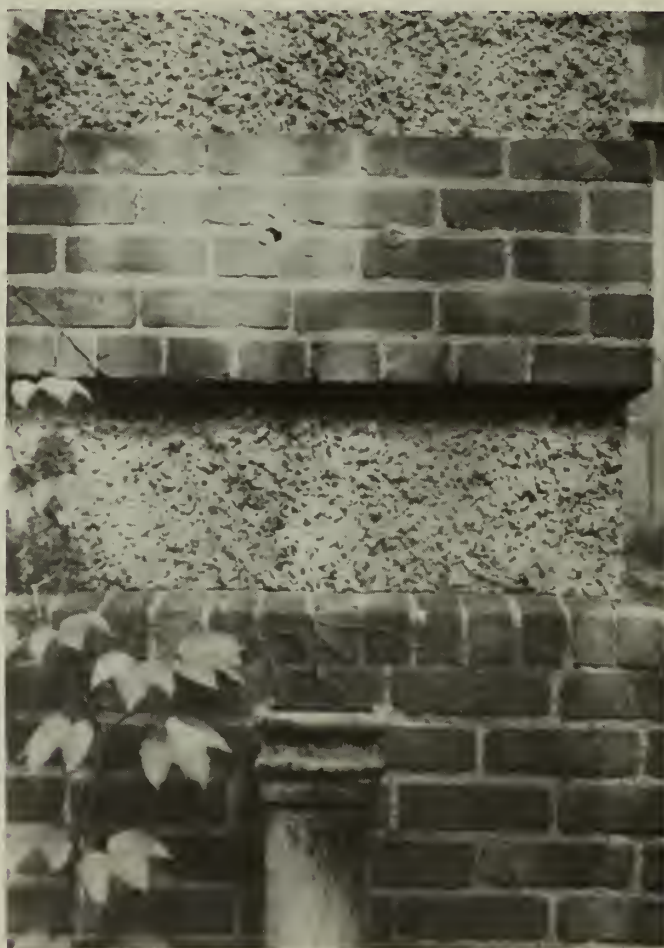
20. Removed downspout, east elevation, north end.

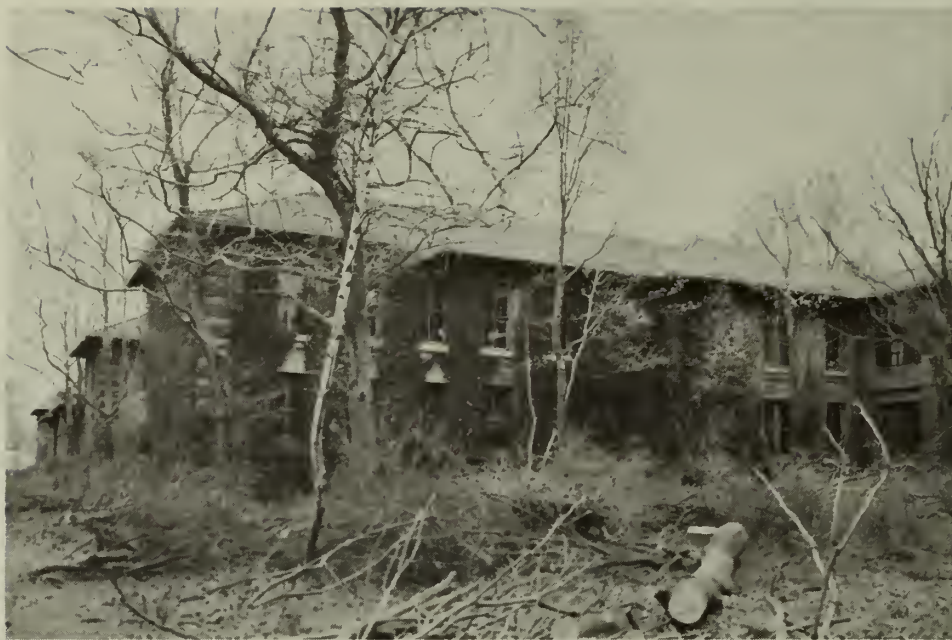
4. Measles ward D, west elevation, view east.

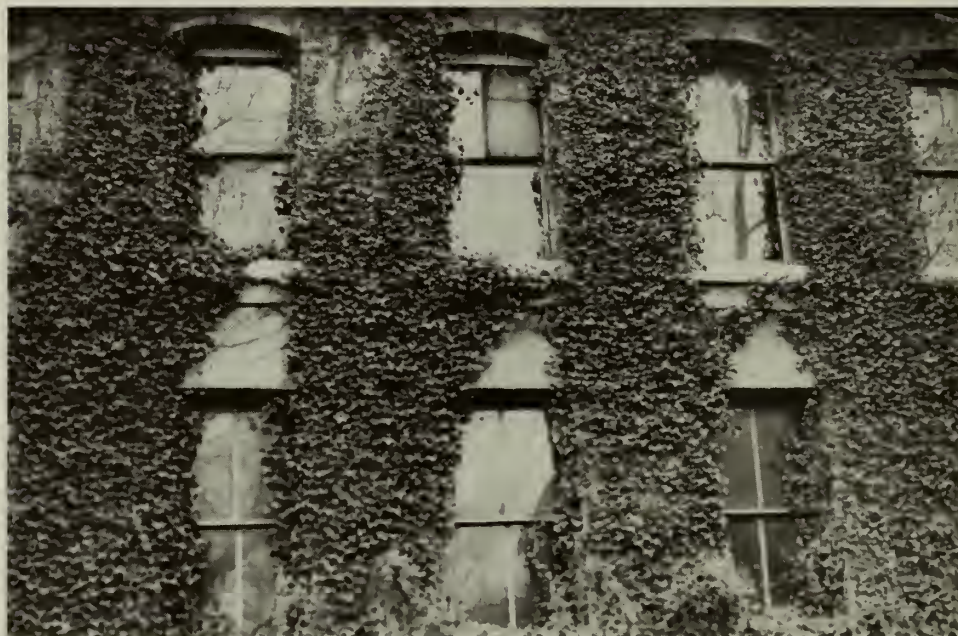
5. Ward D, east elevation fenestration.

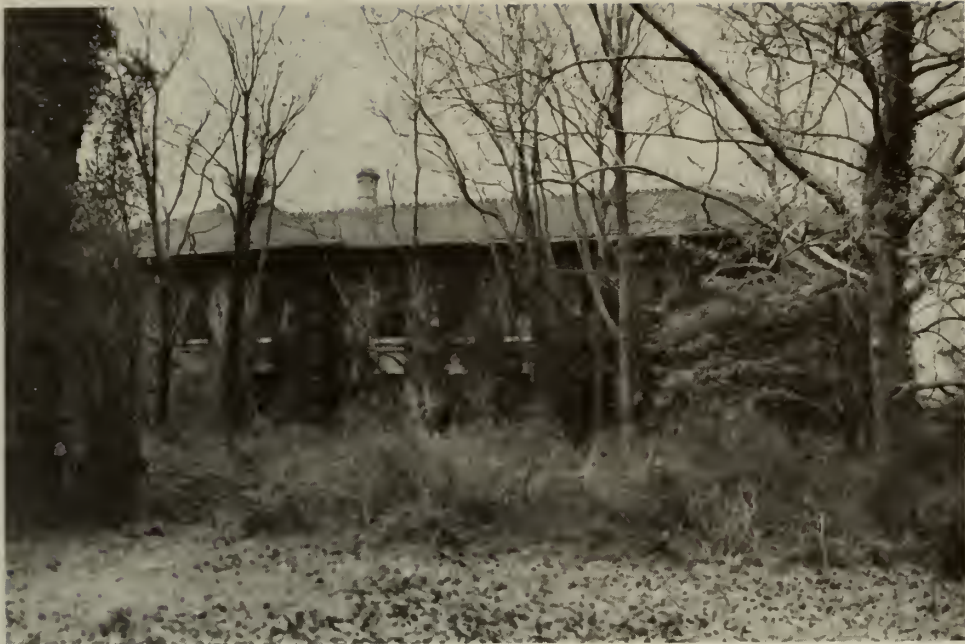
6. Ward C, east elevation, view west.

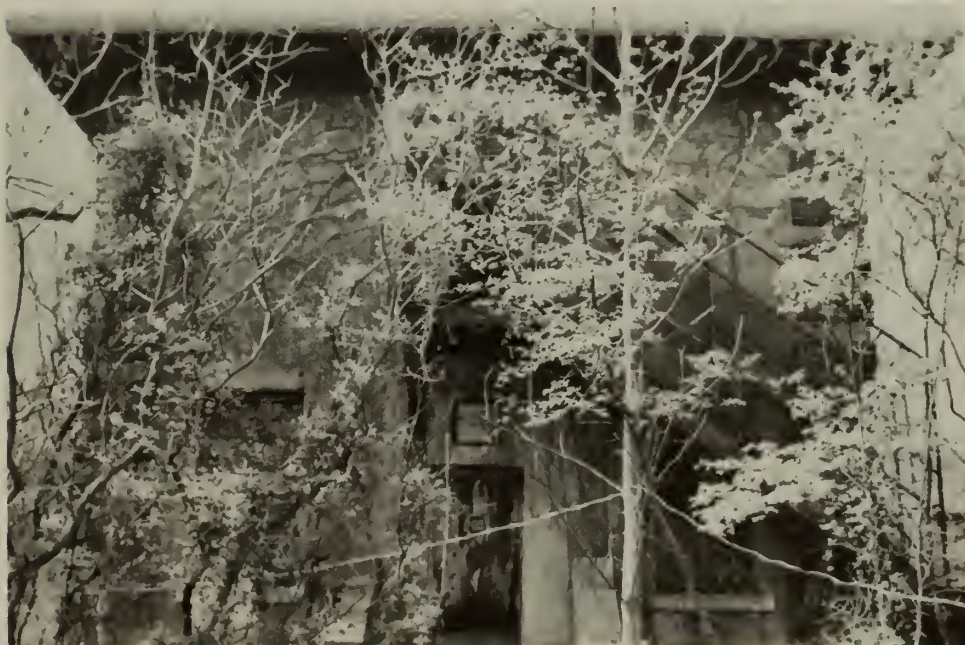
7. Ward G, north elevation, view south.

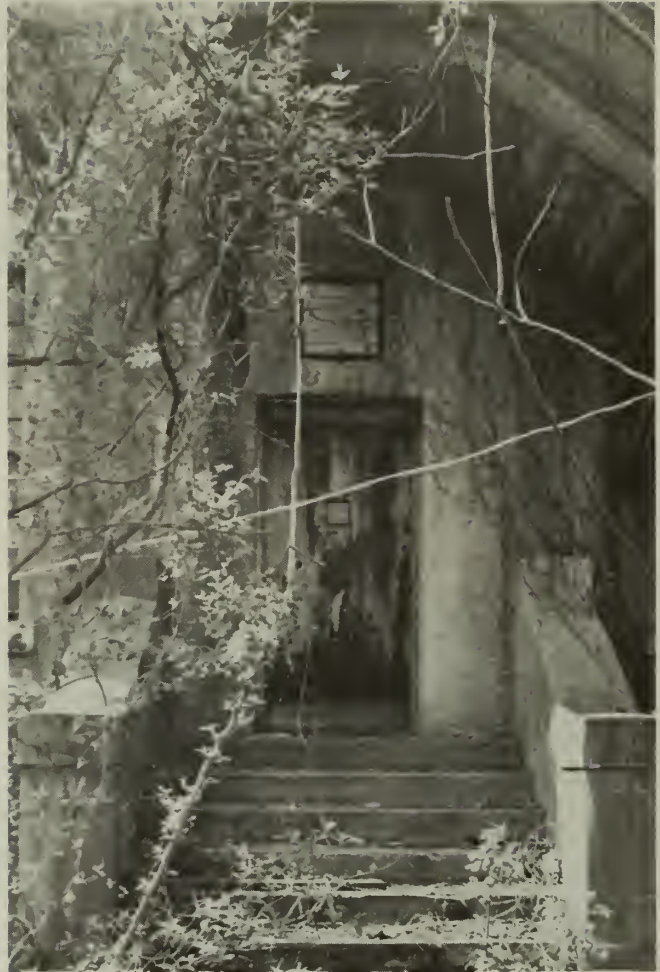
8. Ward G, north elevation,  
first floor entrance.

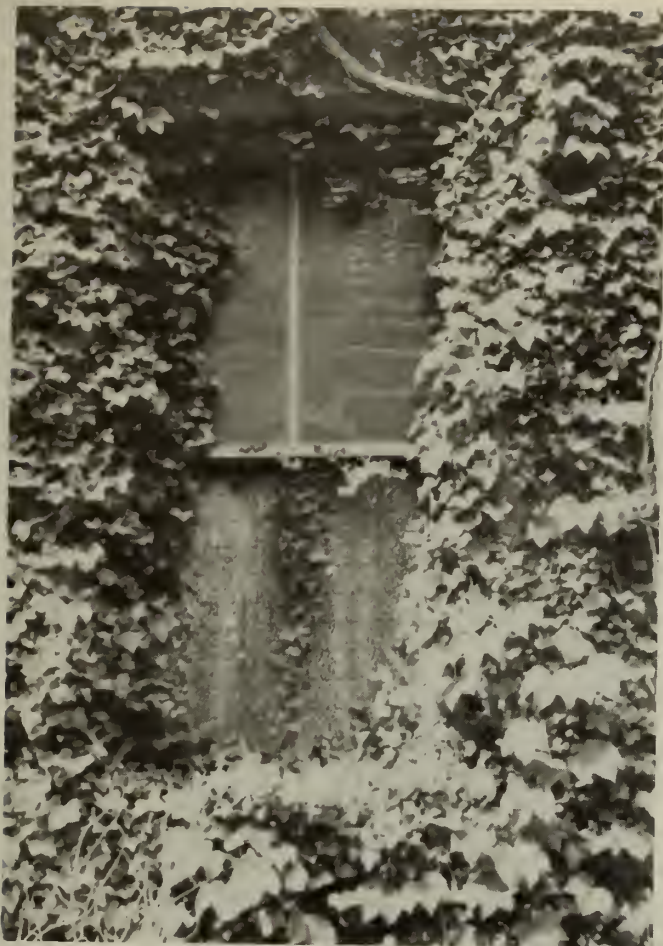
16. Window with textured glass replacement panes, first story, north elevation, administration building.

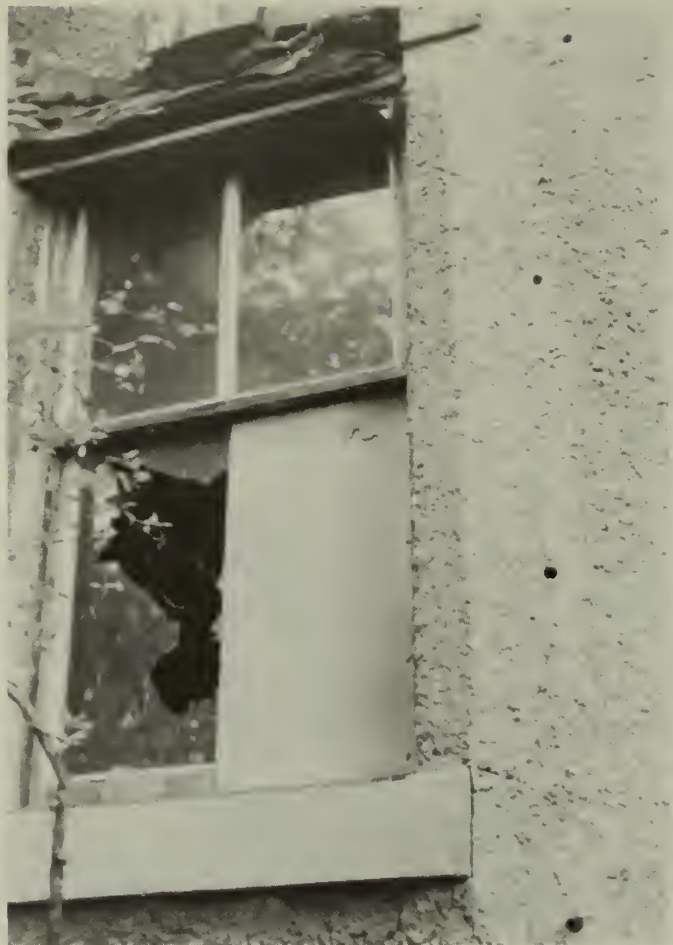
18. Bolt-holes from removed addition, south elevation, kitchen.

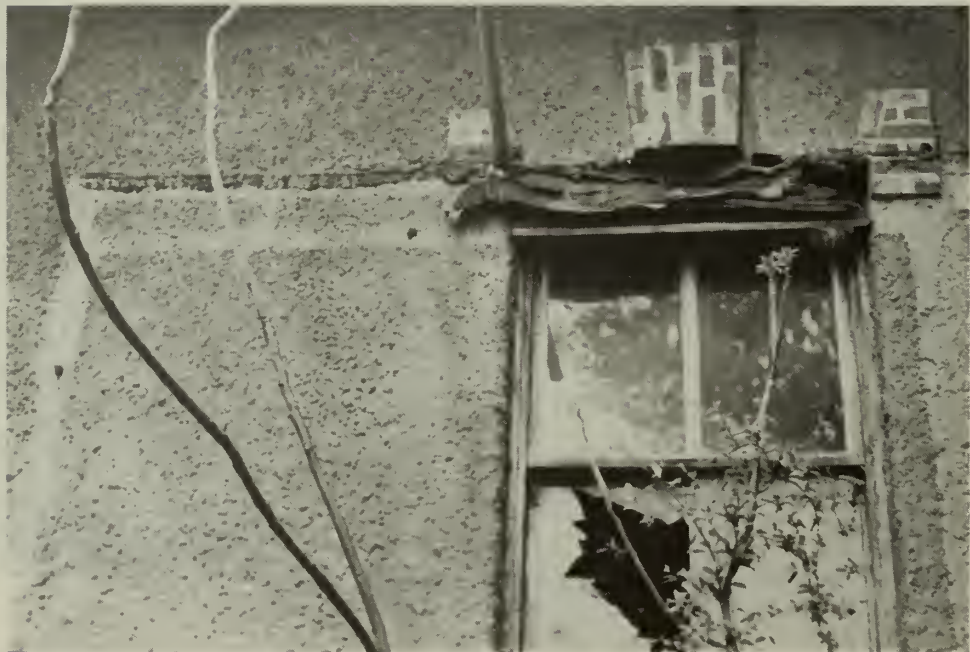
19. Ghost outline of removed addition, south elevation, kitchen.

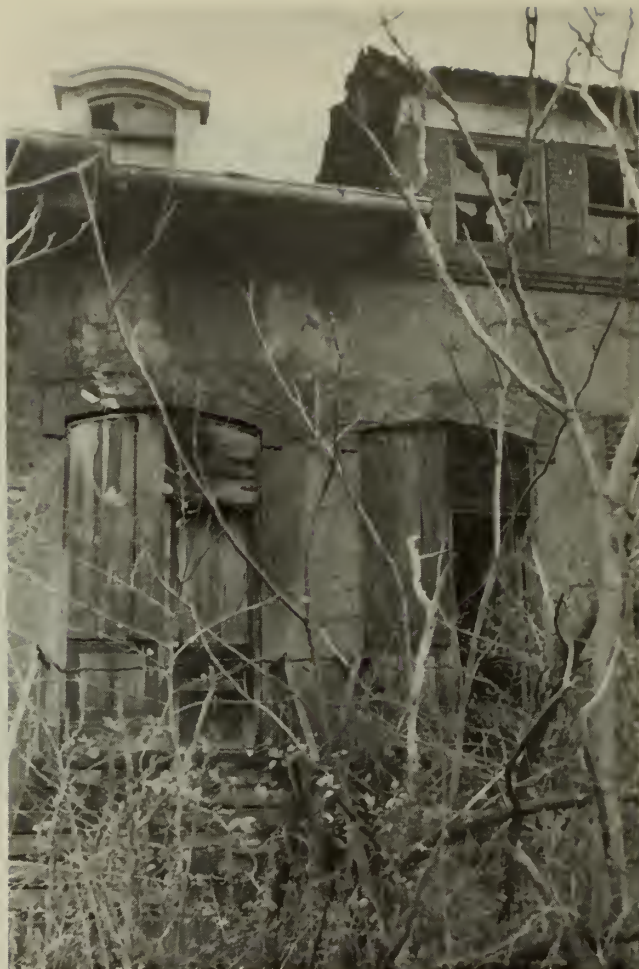
7. Ward K, south facade; boarded-over entrances.

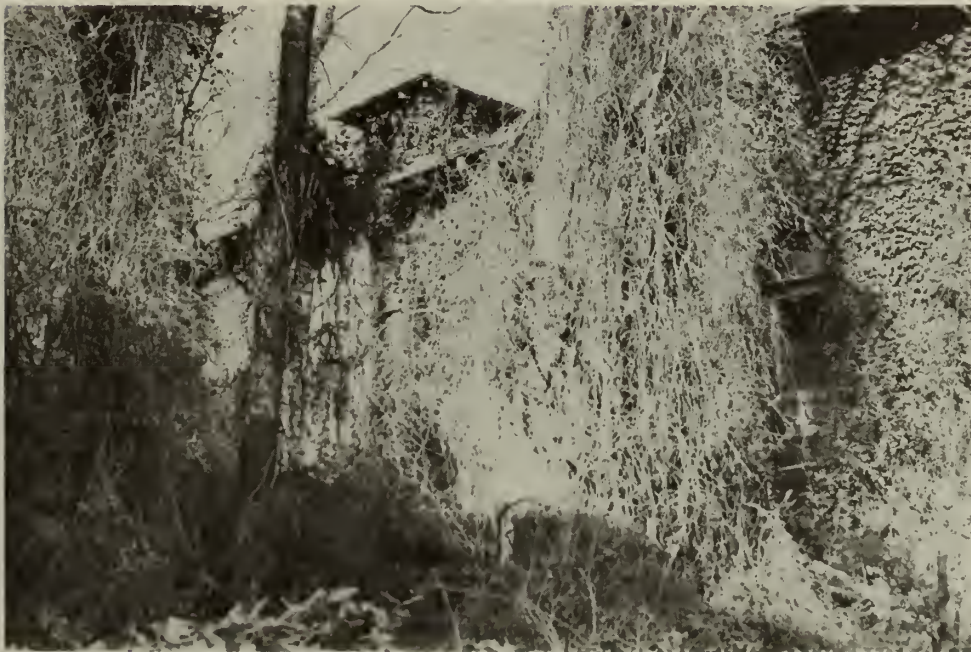
10. Ward L, south elevation, vine cover.

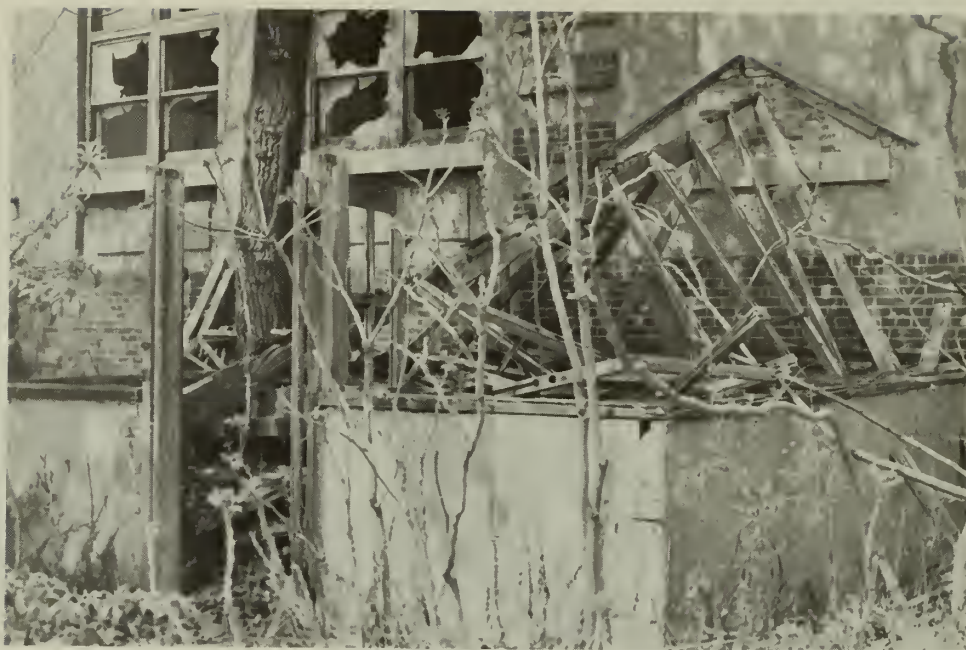
11. Greenhouse structure at south elevation of ward K.

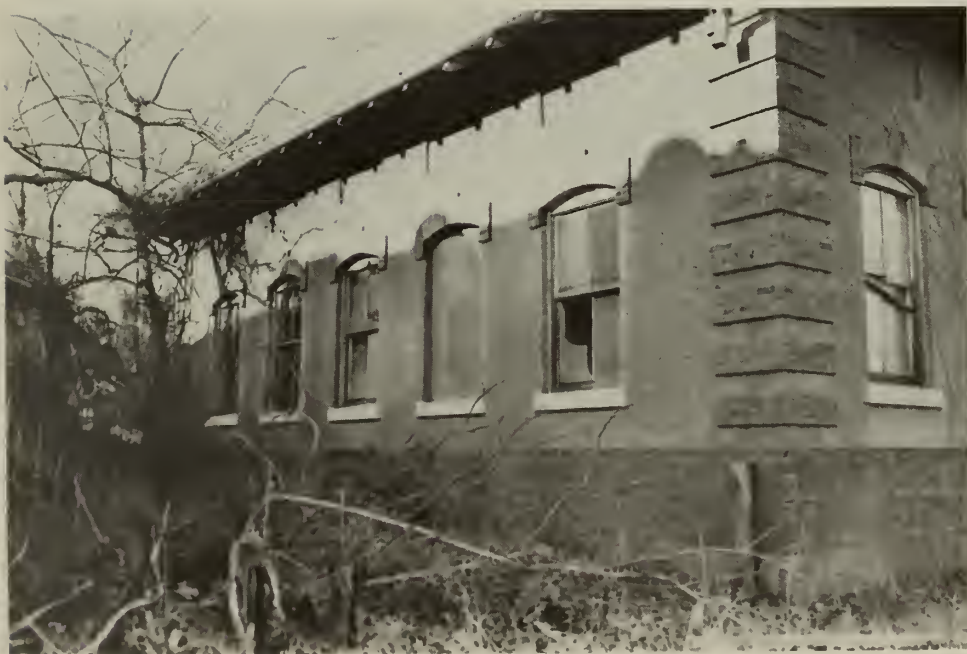
14. Ward L, east facade, infilled window.

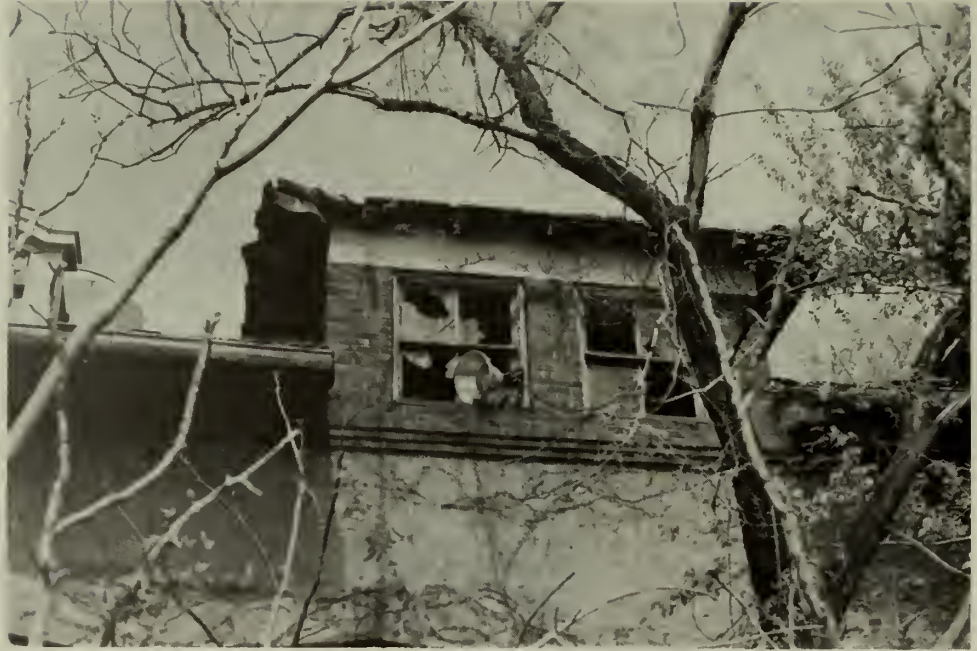
15. Ward K, south elevation, spotlight in dormer.

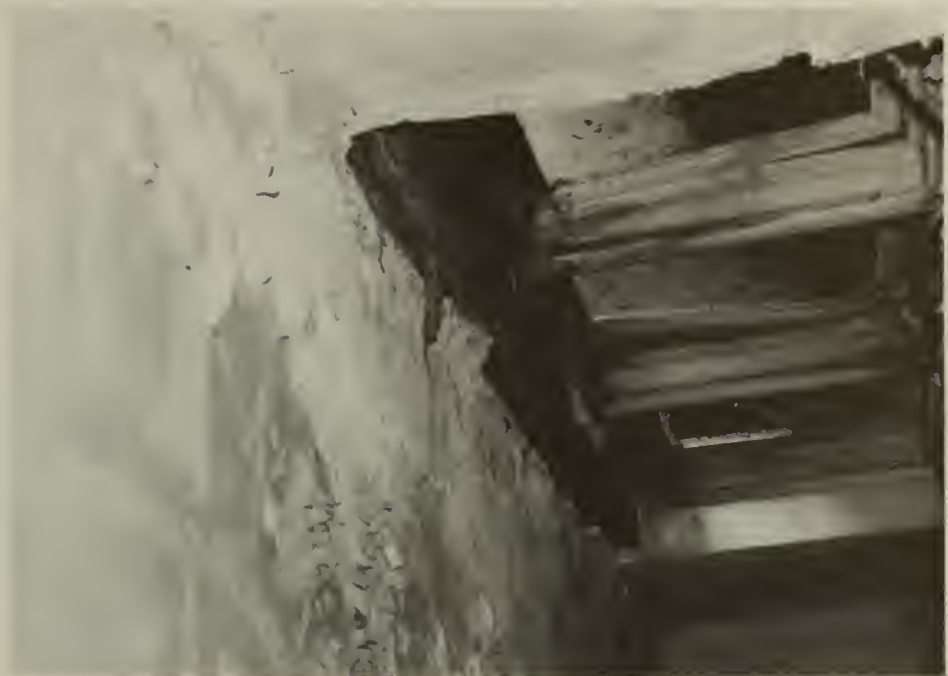
20. Ward I, south stairwell, second floor;  
rotted skylight header and ceiling rafters.

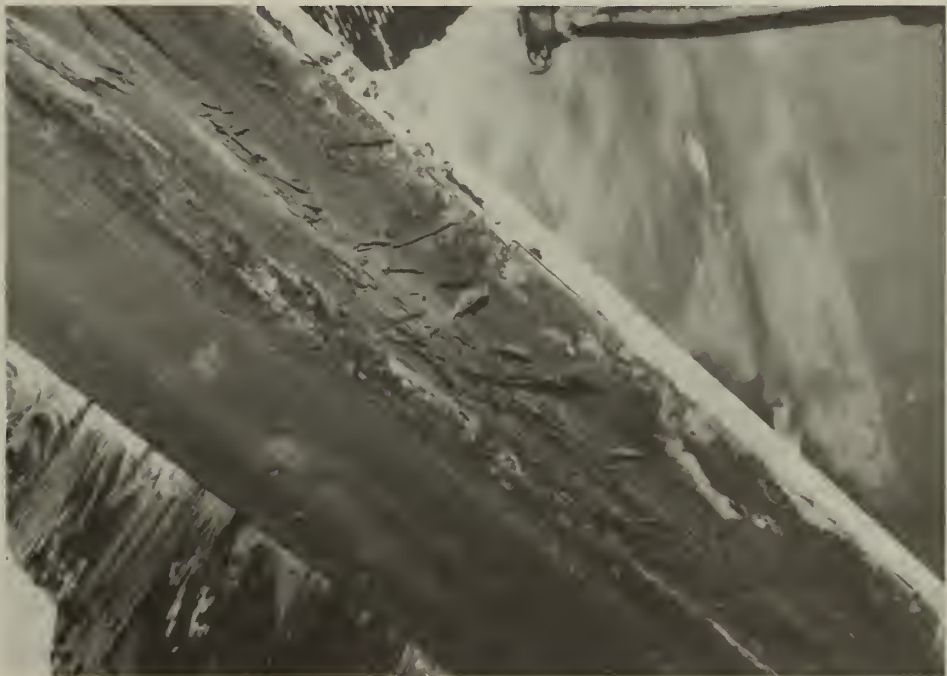
21. Ward I, east dormer; rotted roof beam.

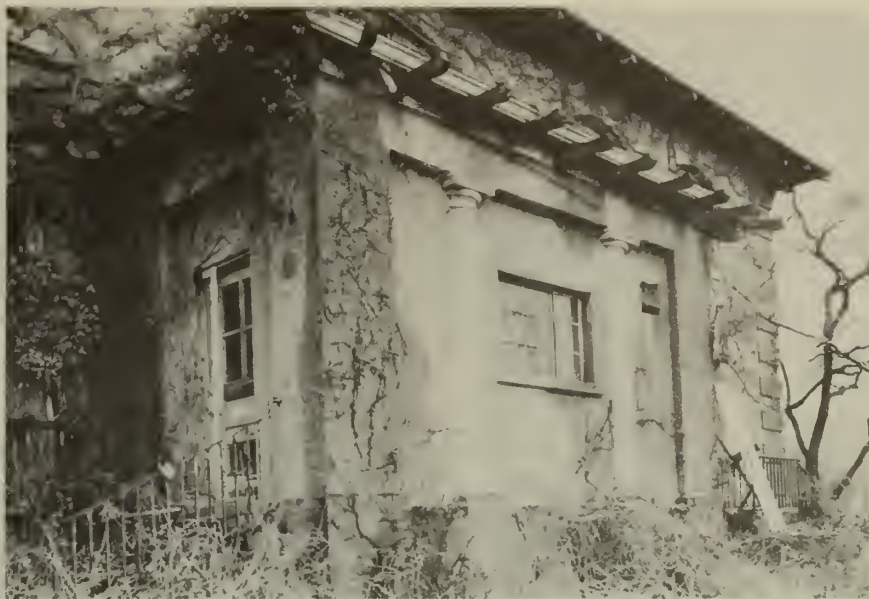
1. Porch, view northwest.

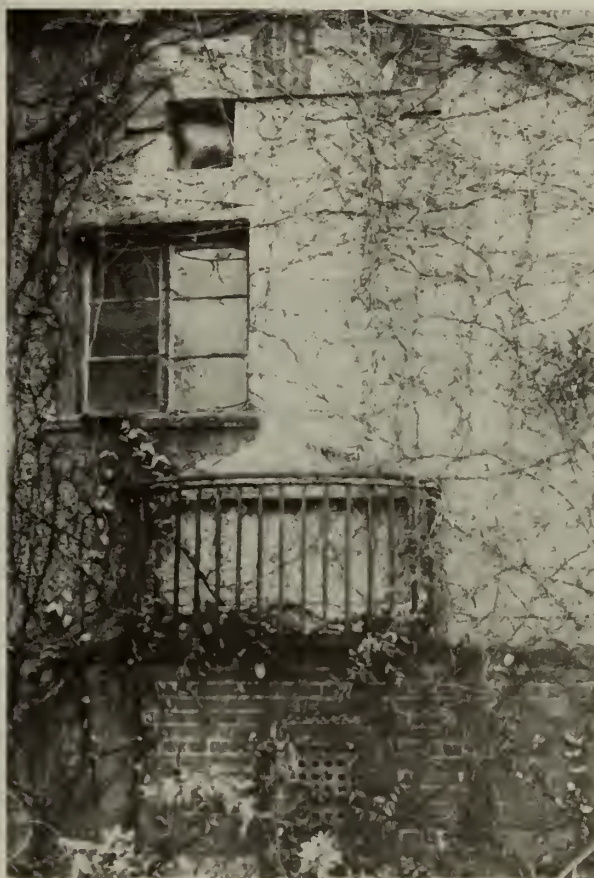
2. Altered window, east elevation.
